Fire Risk Assessment

Responsible Person	Rob Bailey - Building Manager	
Premises Name	Centenary Court	
Address:	Devonshire Drive, Eastwood, Nottinghamshire, NG16 3TR	
Assessor's Name	Martin Hartland	
Date of Assessment	18 th December 2019	Review Date: See ¹ below
Person(s) Consulted:	Rob Bailey - Building Manager	
Date of Previous Fire Risk Assessment	Not applicable

This assessment pertains solely to Centenary Court, Devonshire Drive, Eastwood, Nottinghamshire, NG16 3TR.

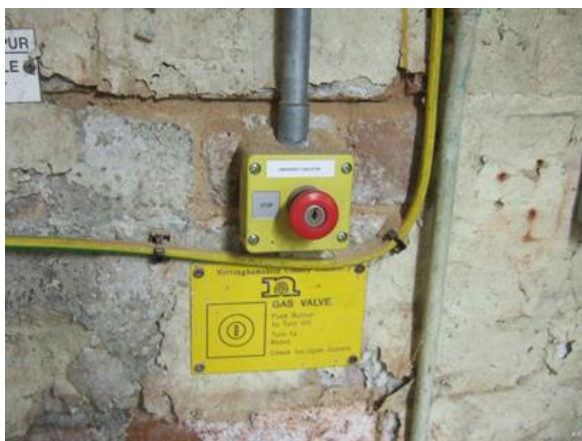
The gas shut off is located in the cellar.

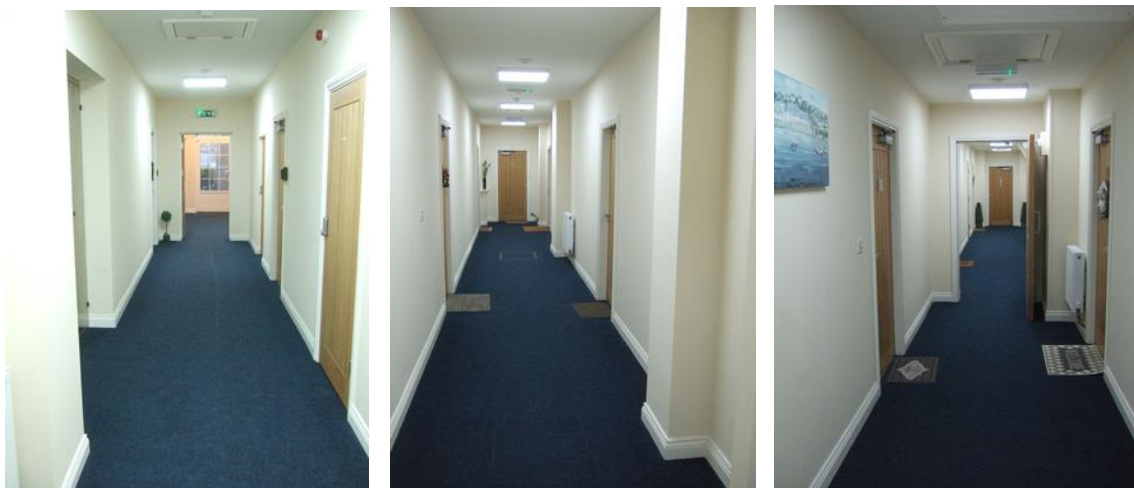
The surface finishes of walls and ceilings in escape corridors, lobbies and stairways can significantly affect the rate of fire-spread and contribute to the development of a fire. It is, therefore, important to control the fire performance of linings within the common parts. As below, there are no significant combustible surface finishes or combustible items in the escape corridors, the lobby or the stairway (below).

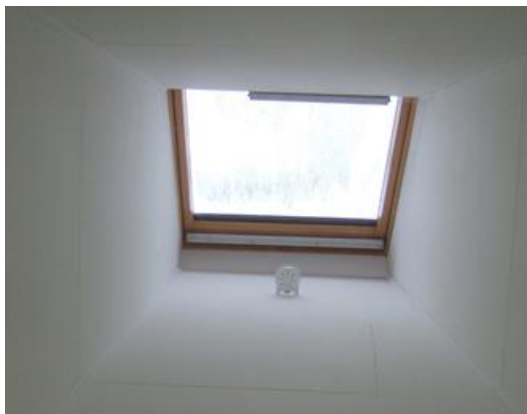
As the building is a single stairway building, an automatically opening vent (AOV) is present in the first-floor corridor ceiling linked to the common areas detection system.

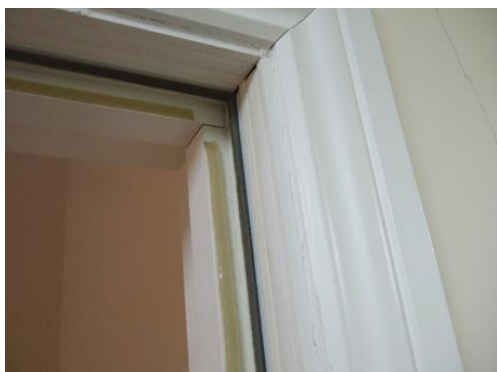
The frame of the fire door leading on to the escape staircase has been fitted with draught proofing foam. This should be removed from the frame as it prevents the door from closing fully.

<p>13.9</p>	<p>The frame of the fire door leading on to the escape staircase has been fitted with draught proofing foam. This should be removed from the frame as it prevents the door from closing fully.</p> <p>It was also noted that there is a gap in the electricity meter cupboard ceiling. Although quite small this gap should be suitably fire stopped so that any fire in this area is fully prevented from spreading upwards out of the cupboard.</p> <p>See photos in Section 13.9</p>	<p>Medium</p>

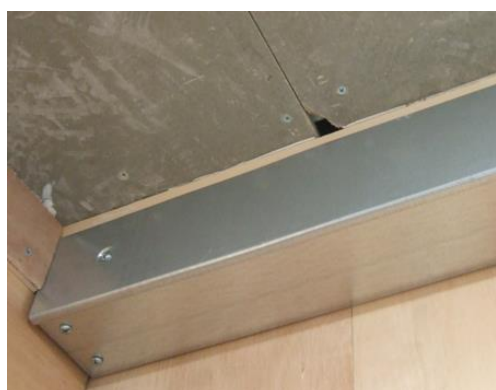
It was also noted that there is a gap in the electricity meter cupboard ceiling. Although quite small this gap should be suitably fire stopped so that any fire in this area is fully prevented from spreading upwards out of the cupboard.

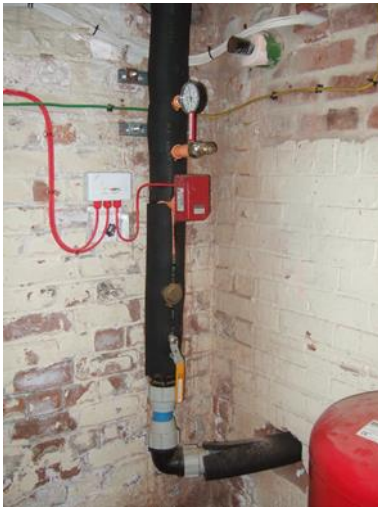
A wet pipe type sprinkler system is installed throughout the building including the common areas and resident's flats. The isolation valve and test points are located in the cellar.

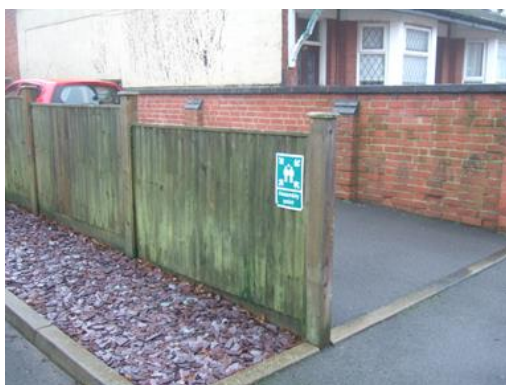
A fire assembly point is designated and signed at the entrance to the site.
